BEFORE THE IDAHO PUBLIC UTILITIES COMMISSION

IN THE MATTER OF DIAMOND BAR)	
ESTATES WATER COMPANY'S)	CASE NO. DIA-W-15-01
APPLICATION FOR AUTHORITY TO)	
INCREASE ITS RATES AND CHARGES FOR)	COMMENTS OF THE
WATER SERVICE IN THE STATE OF IDAHO.)	COMMISSION STAFF
)

On August 27, 2015 AEI Engineering, Inc. made its initial site visit for the purpose of providing condition assessment and evaluation of the well house's electrical system serving the well pump. The scope of this evaluation included analysis of the utility service, surge protection devices, grounding system and pump motors.

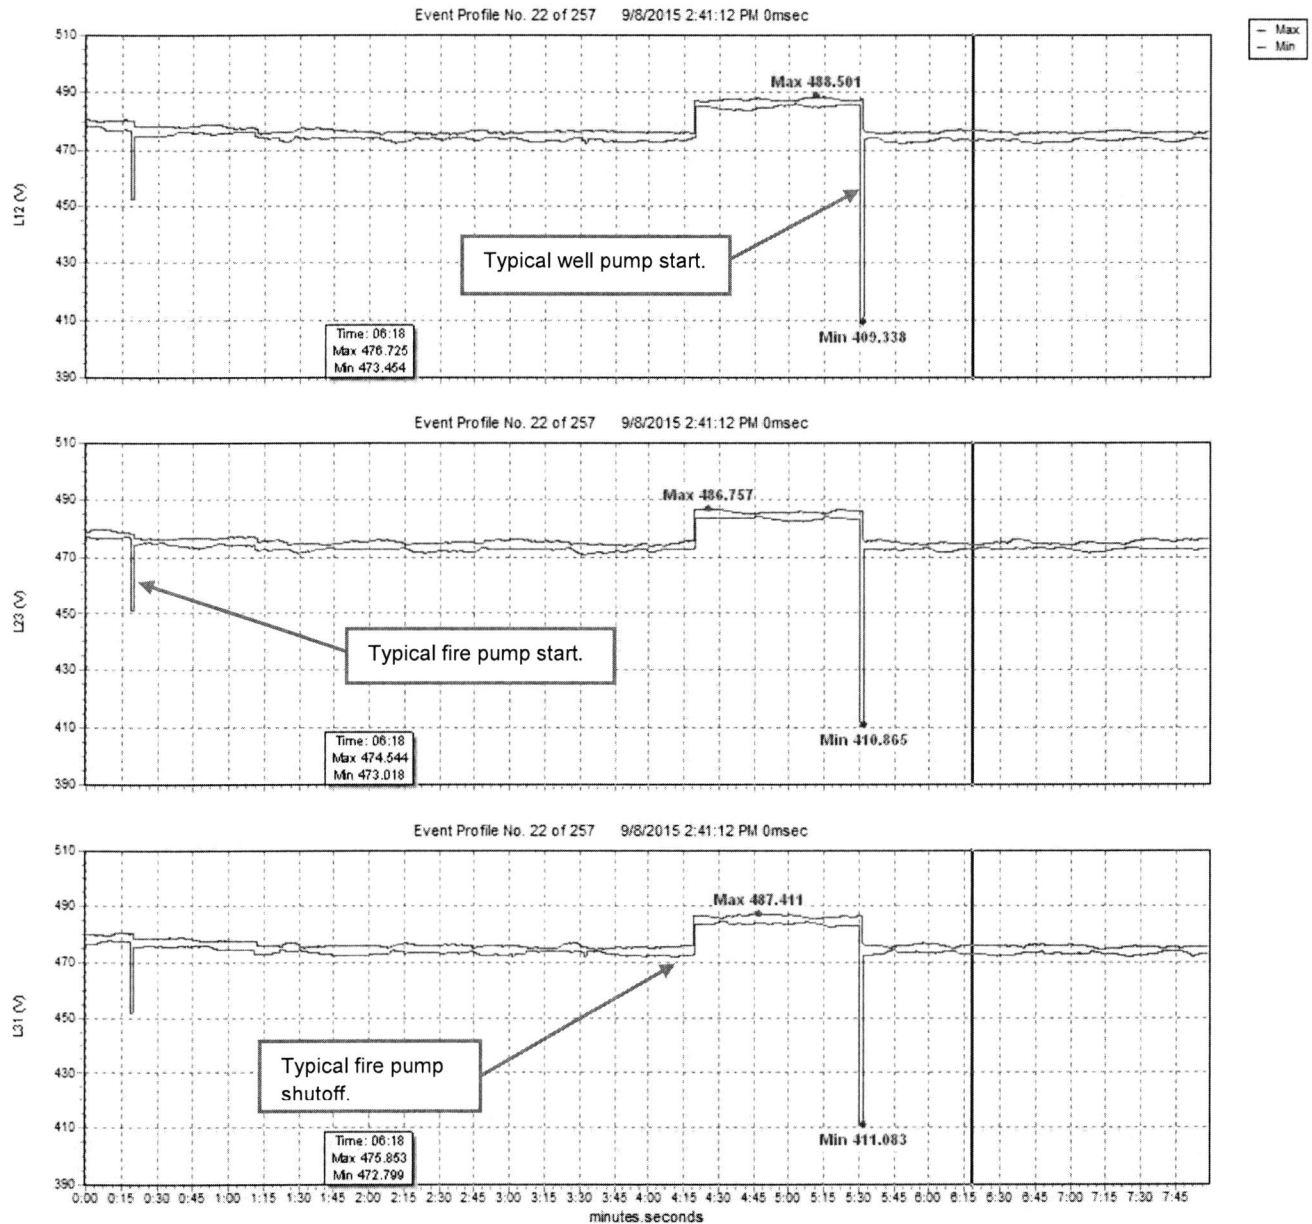
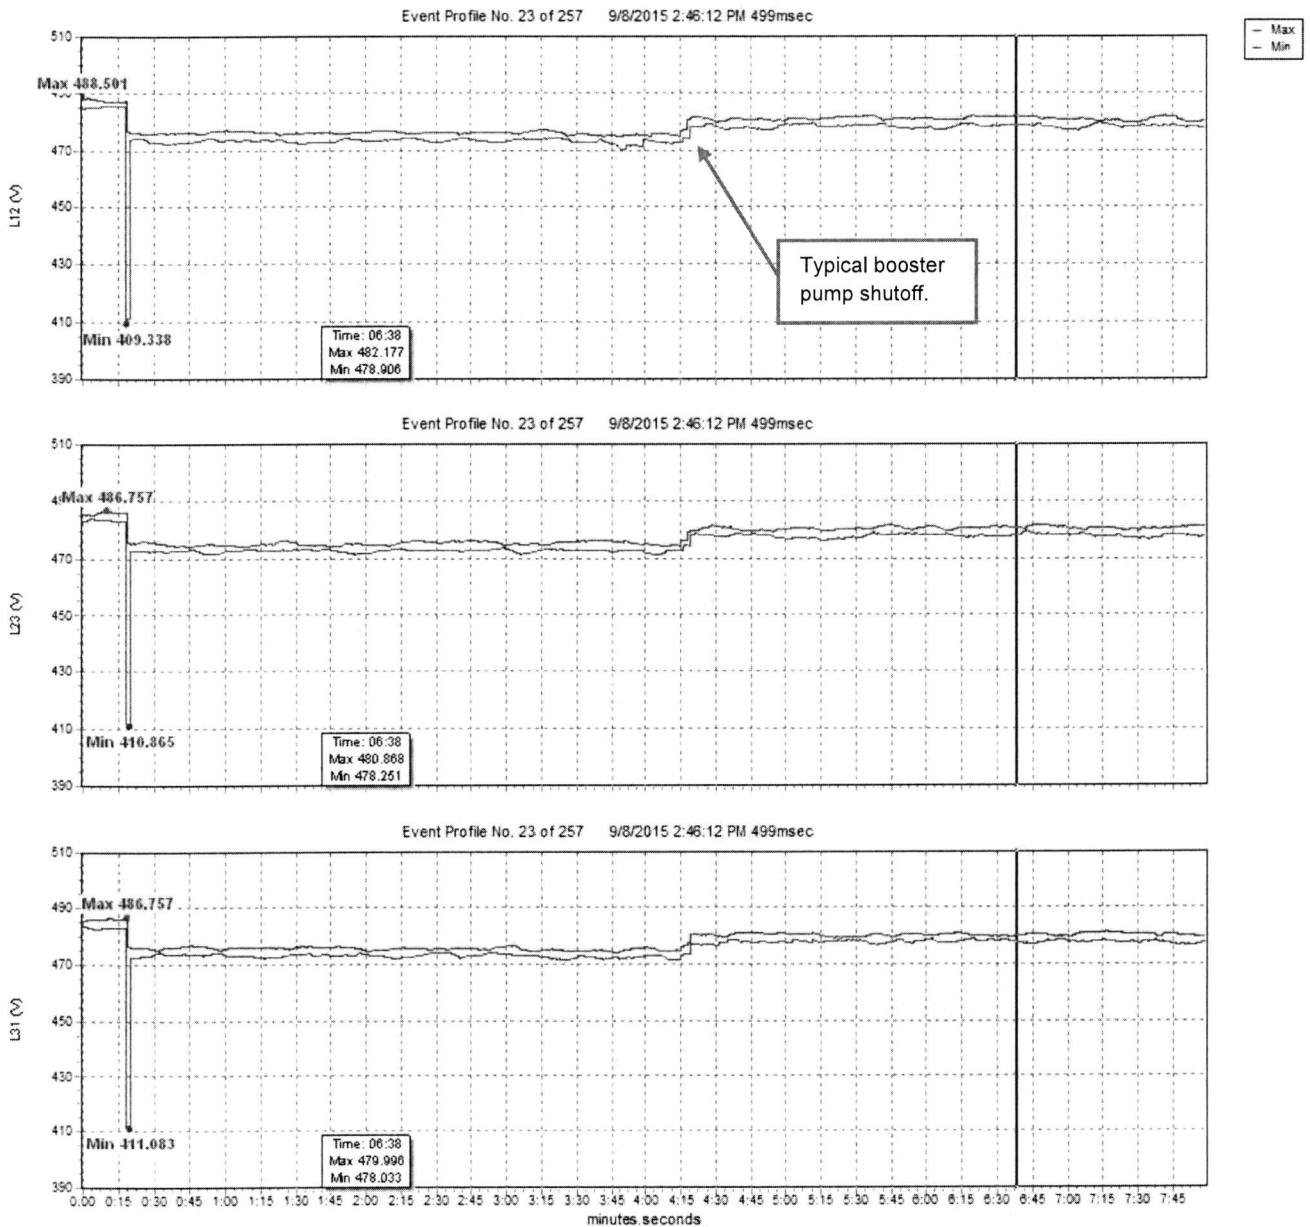
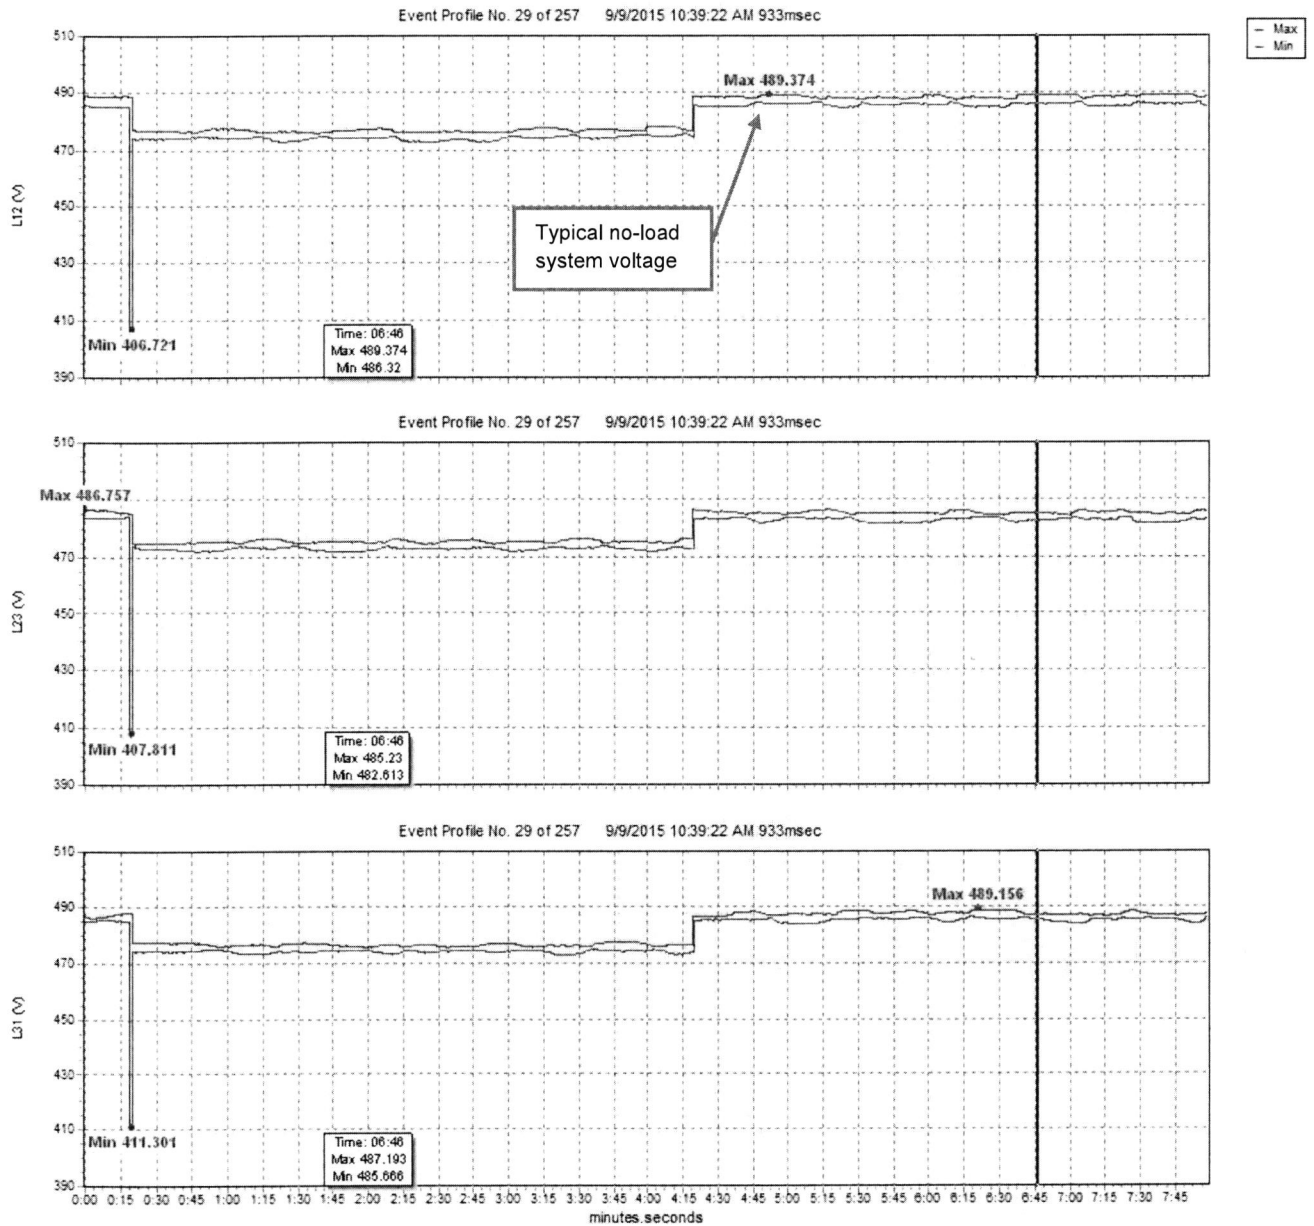
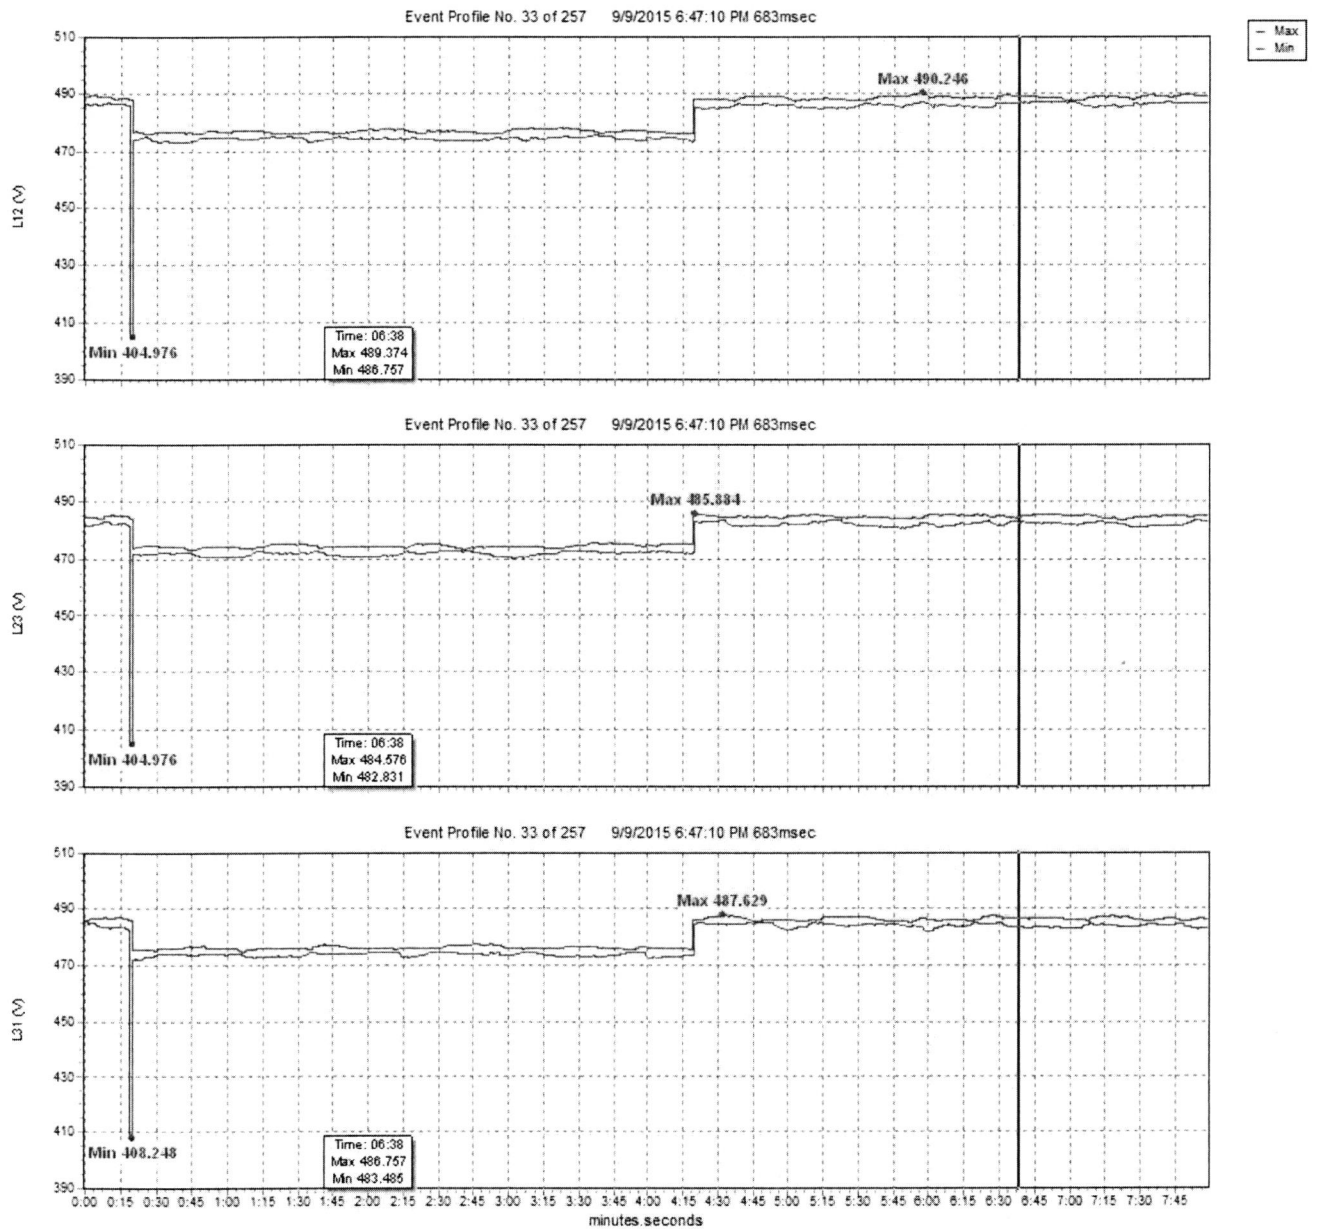
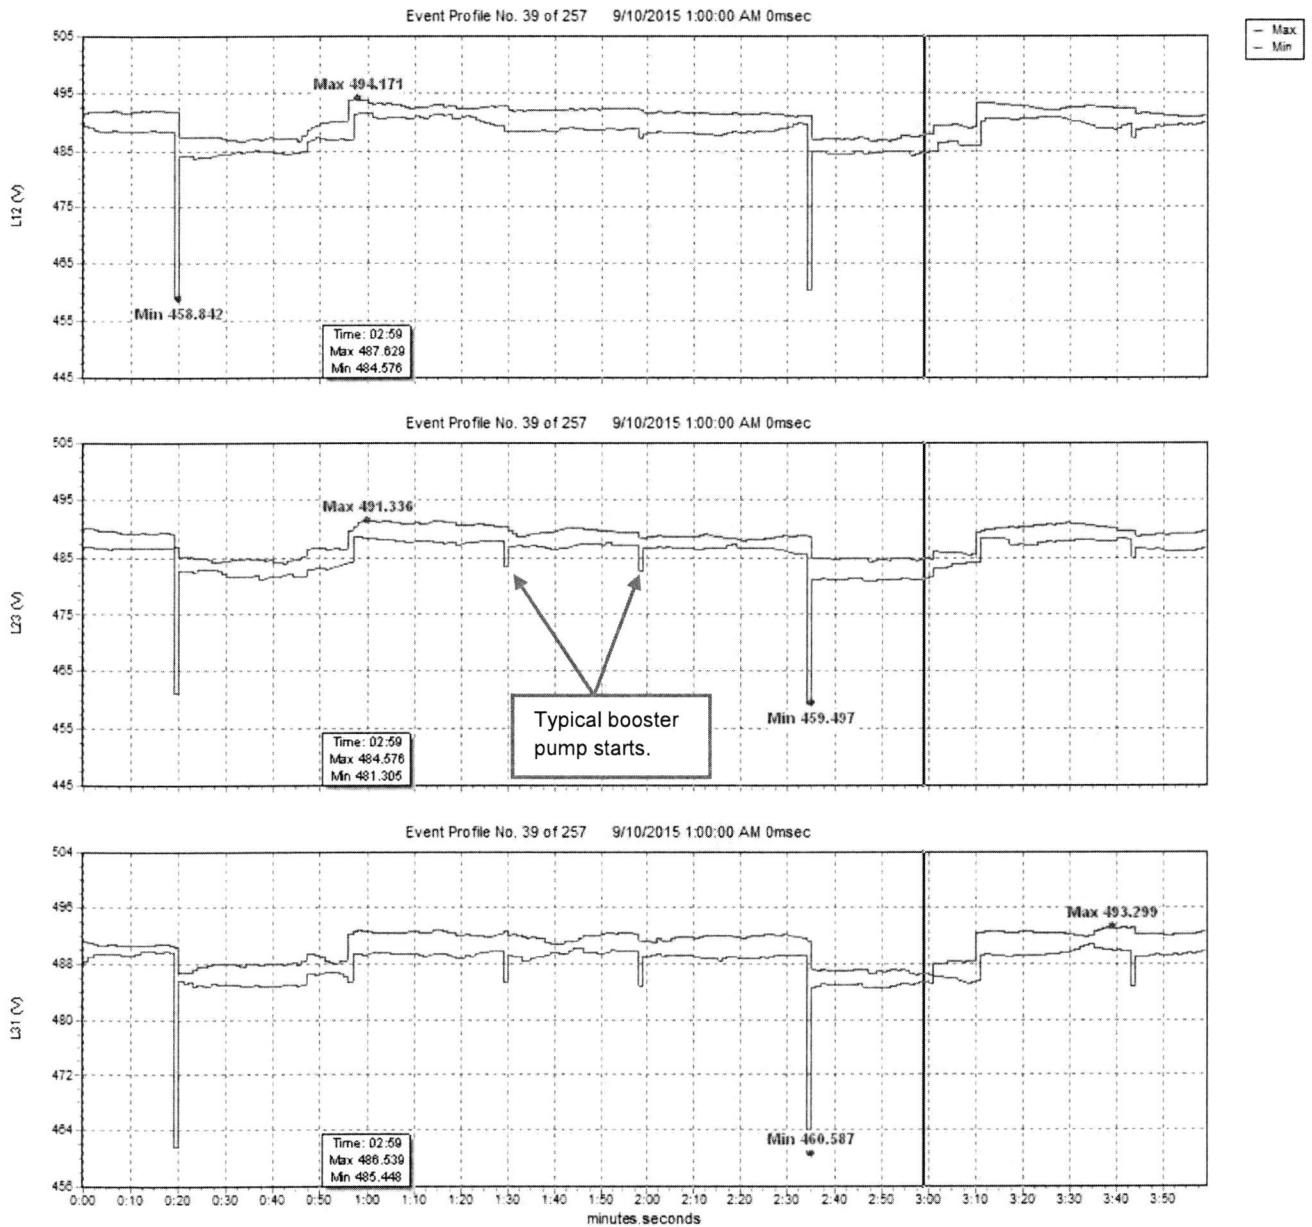
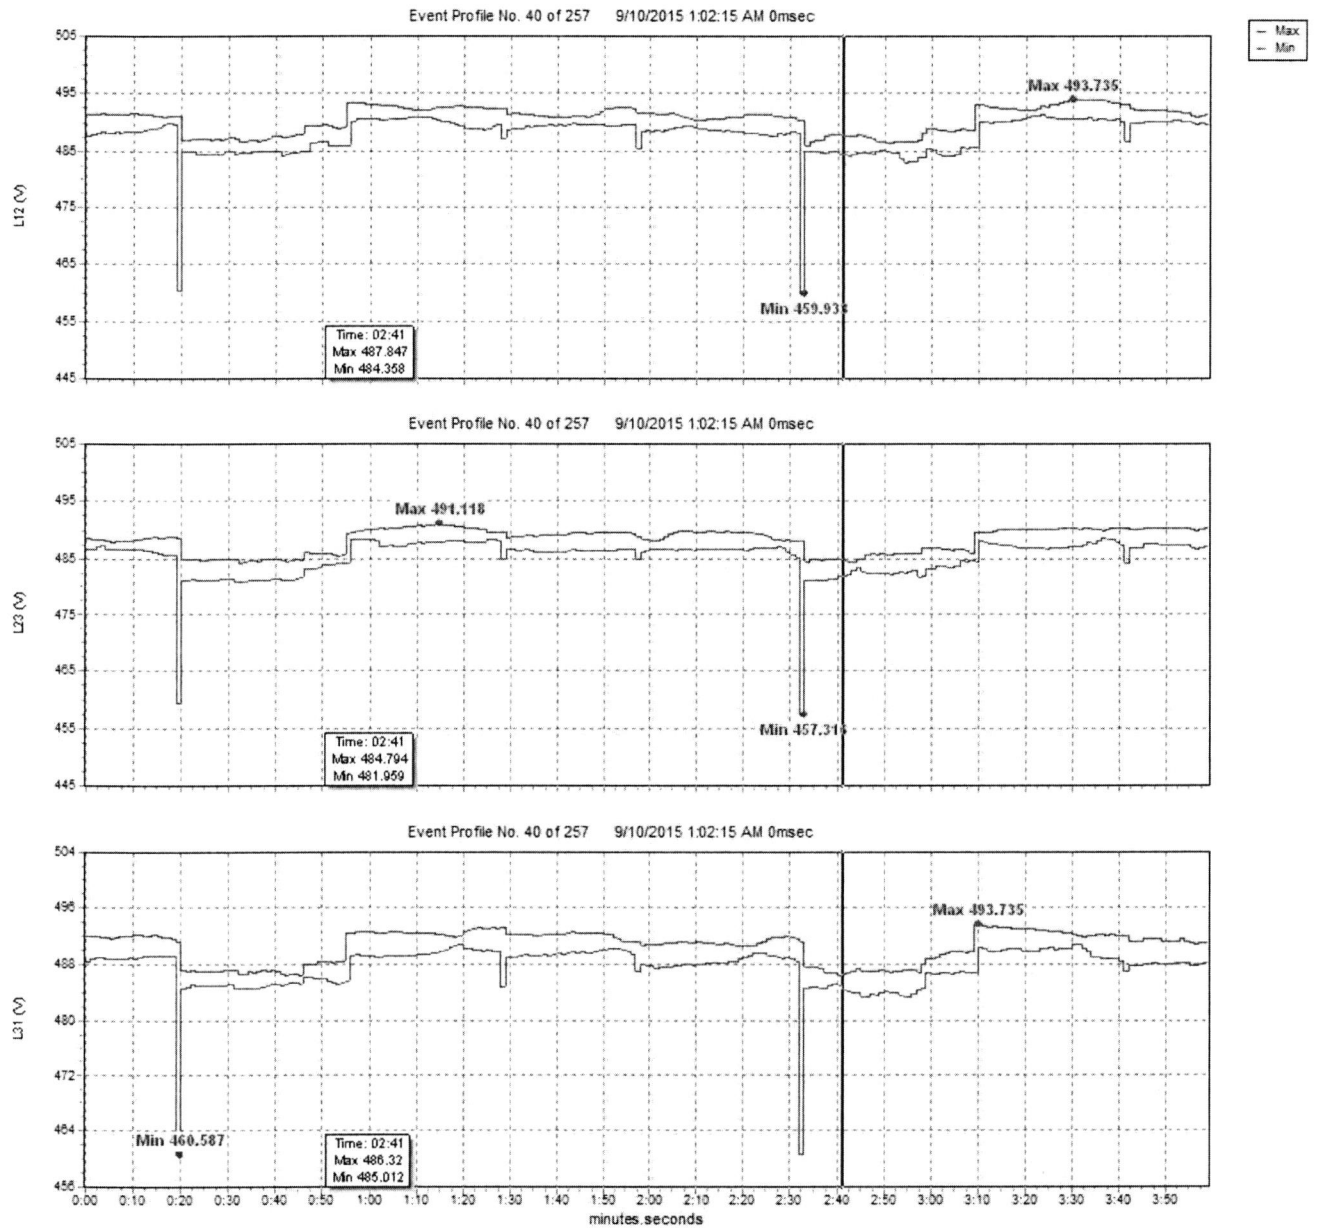
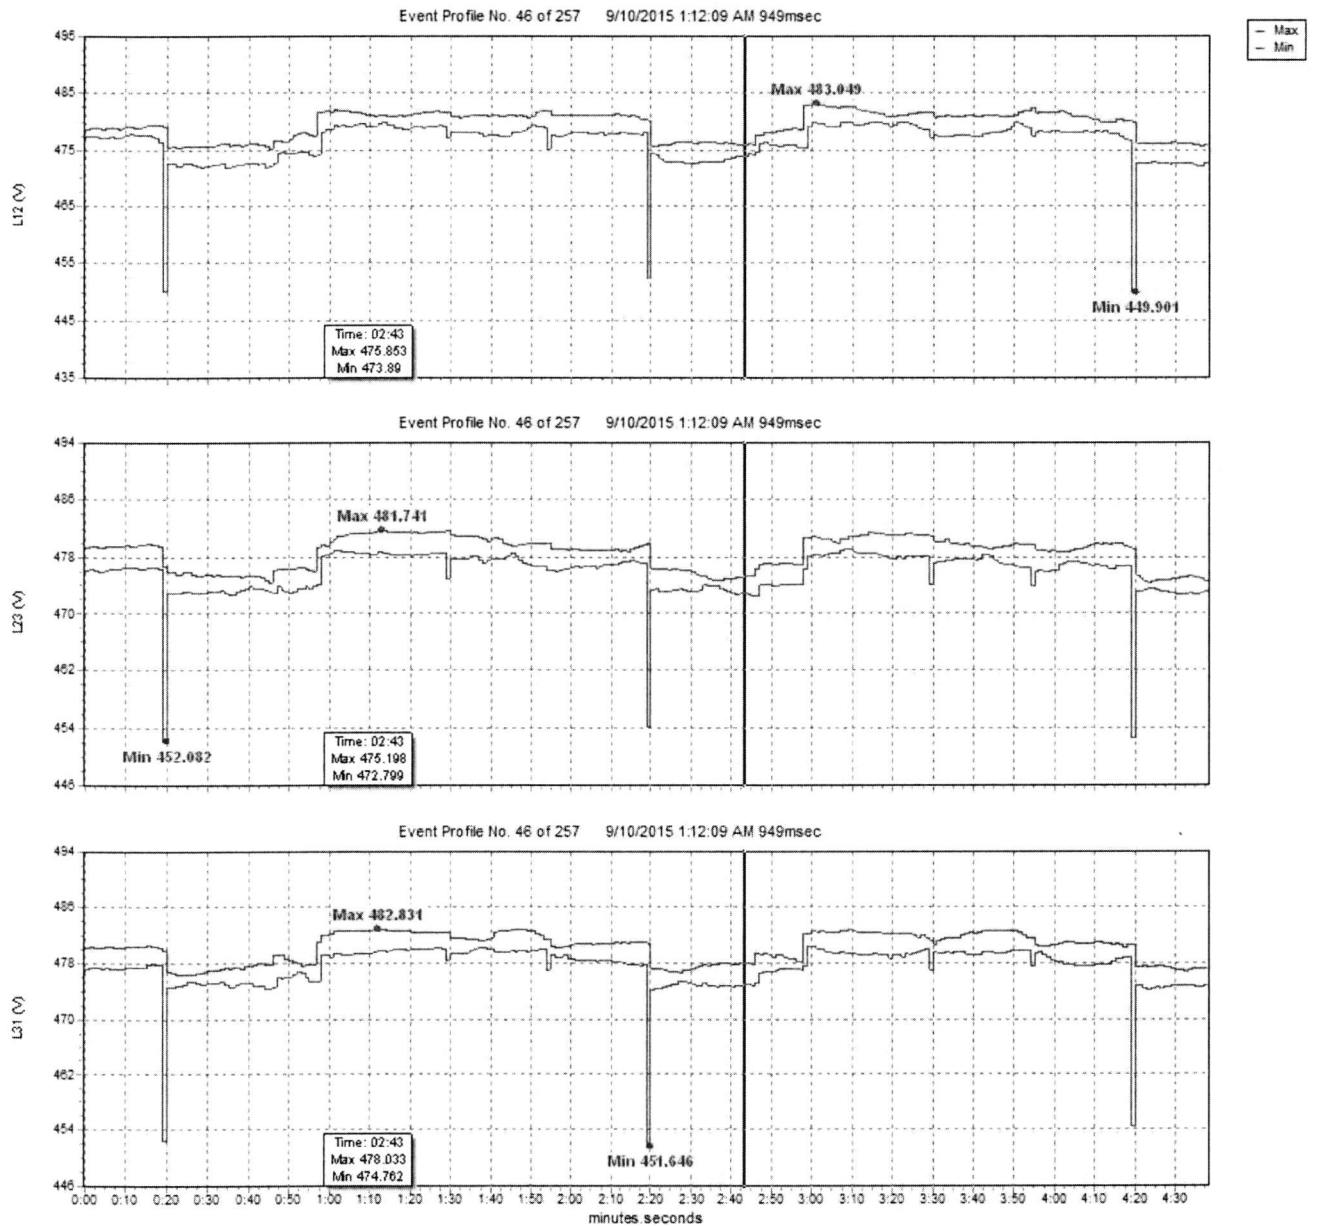
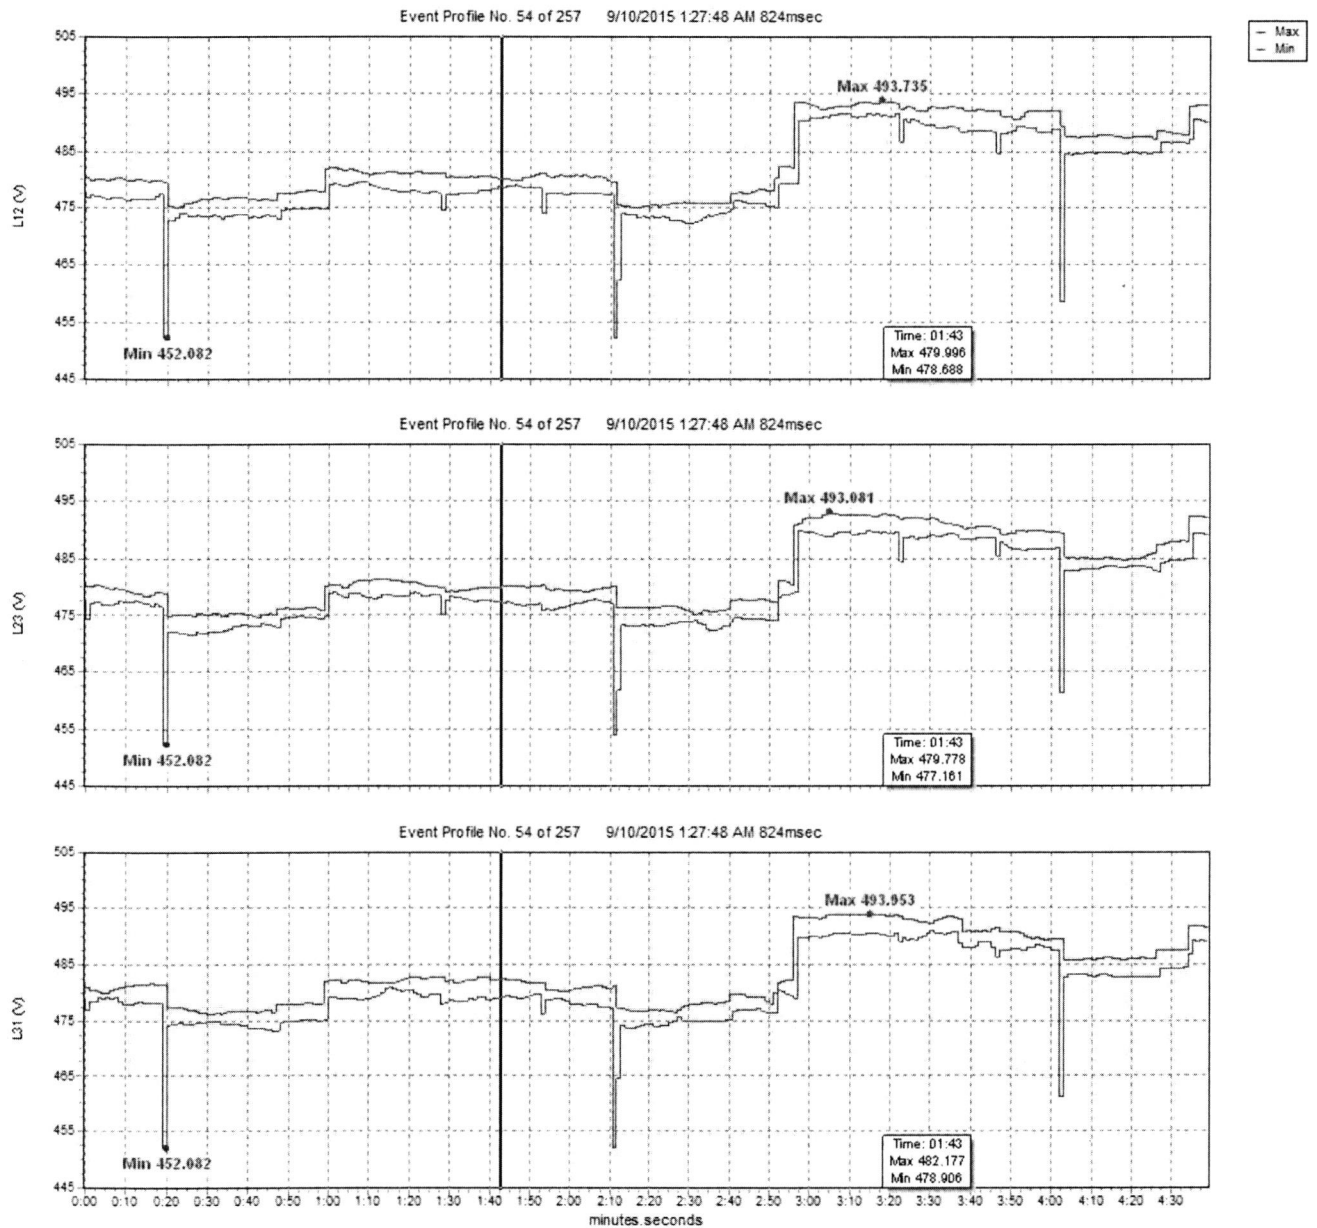
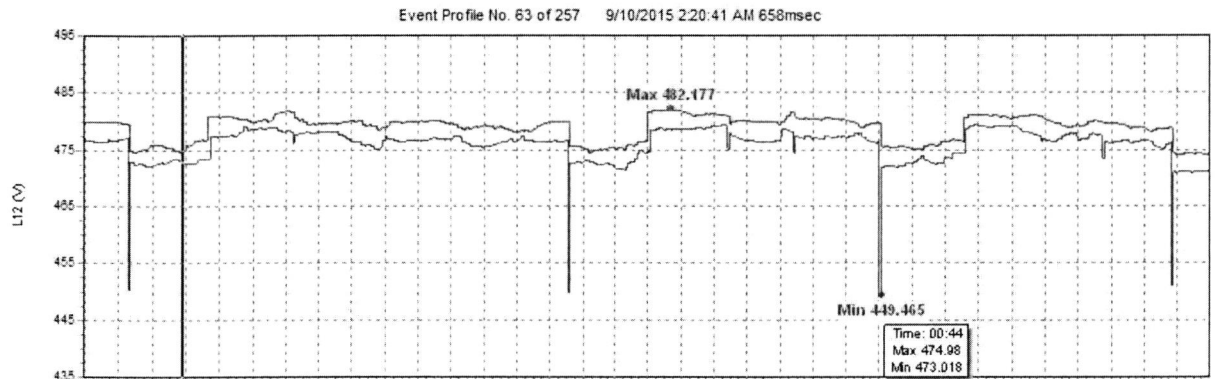
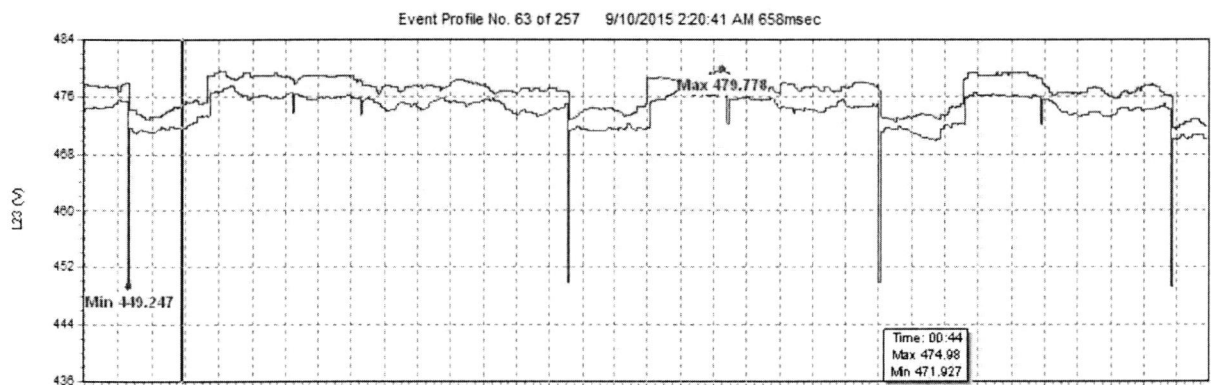
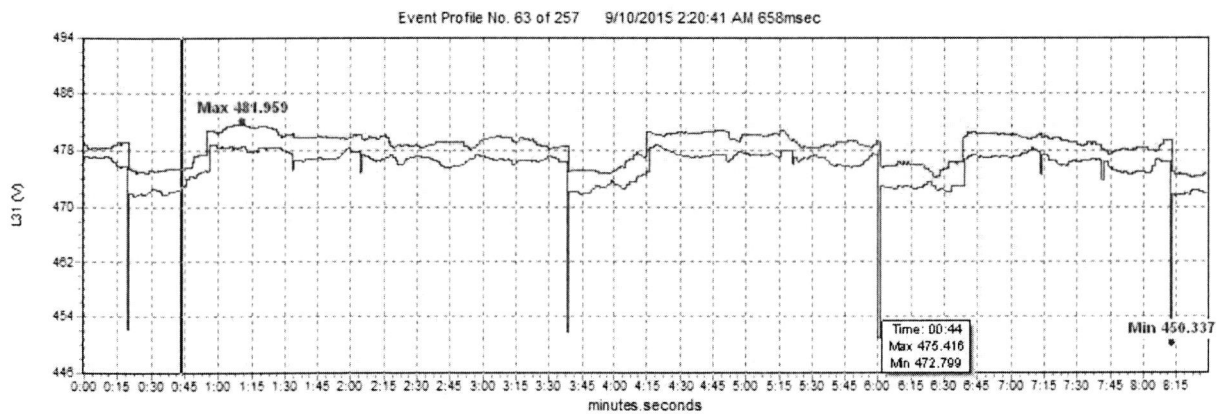
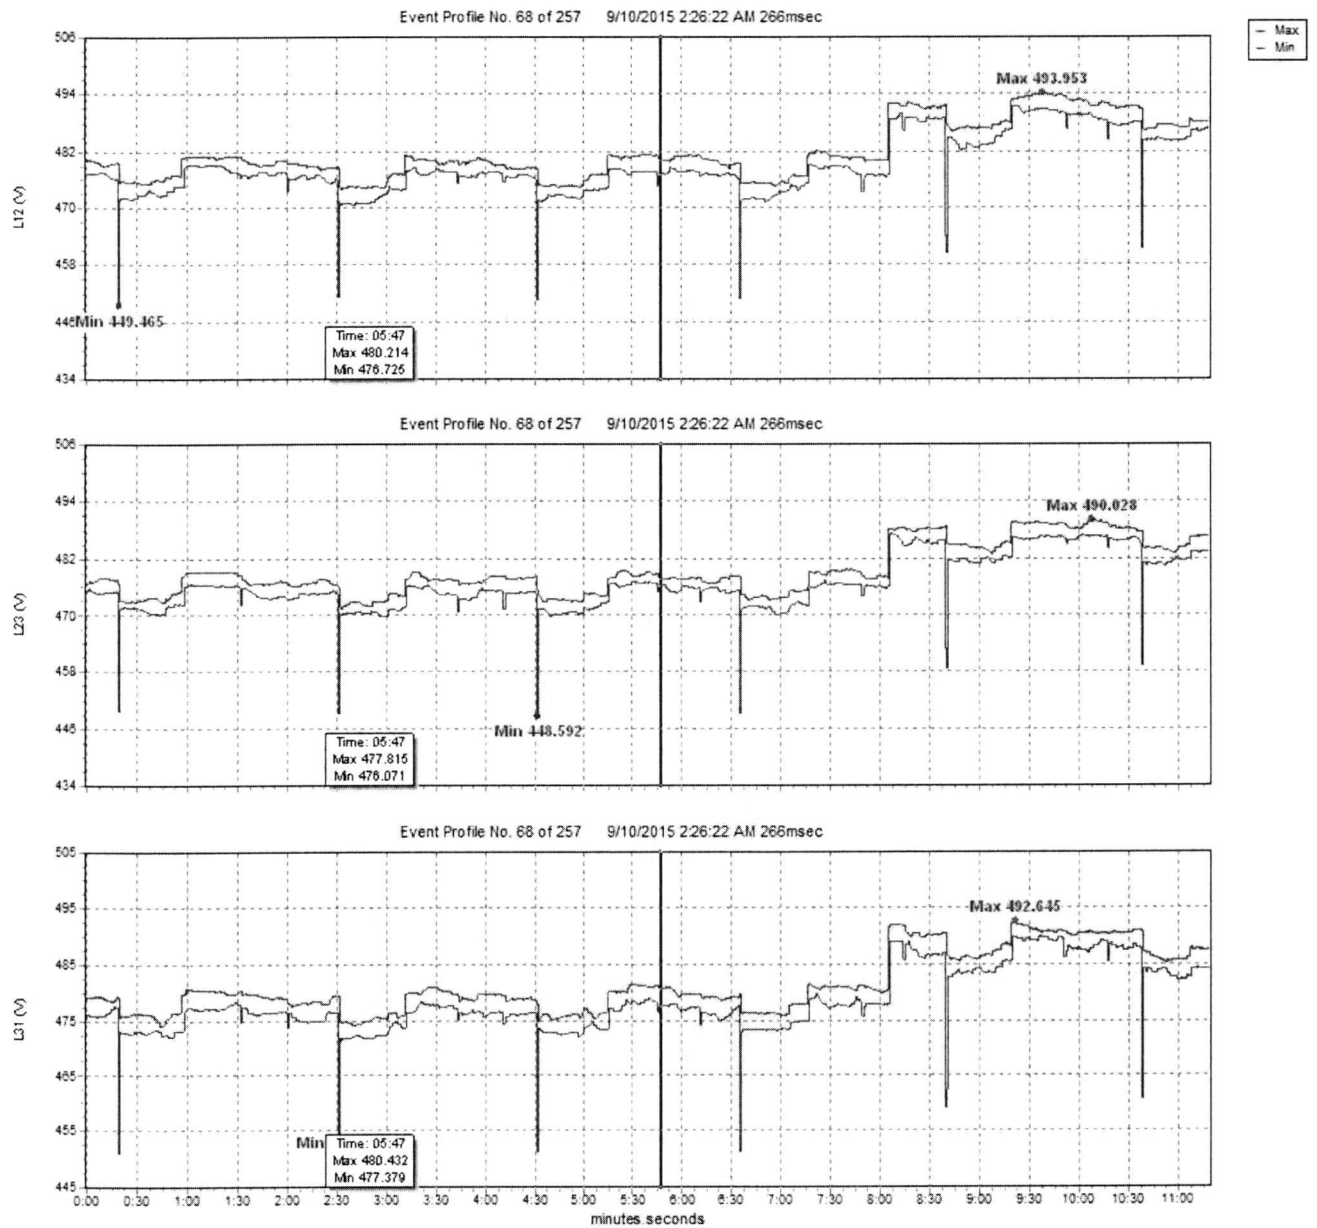
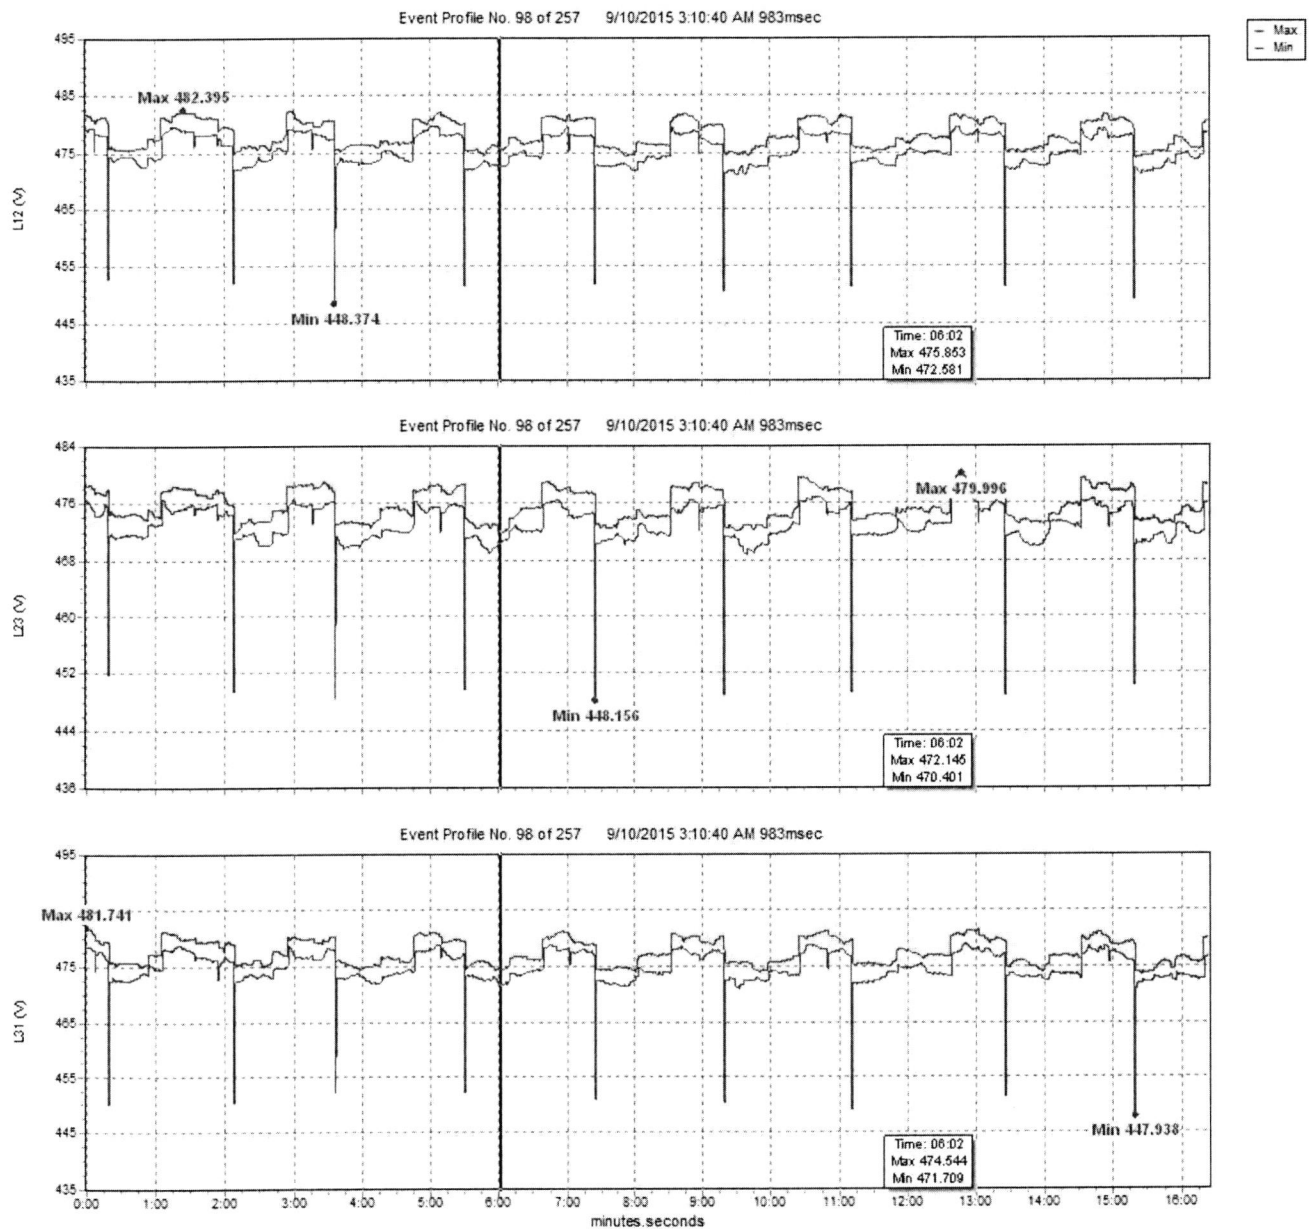
AEI Metering Report: Per Appendix E, AEI Field Report, the voltage drop from the well pump starter panel to the motor terminals was calculated to be approximately 11.8 volts. Therefore, when voltage at the starter panel is measured to be 471.7 volts or less, the motor is not being provided its rated voltage of 460 volts. Sustained voltage sags below the motor's voltage rating will be indicated in the following pages by a RED rectangle. Note that sustained voltage sagging occurs on the last day of recording. Other indications will be explained via text box.
